Manhole Inspection Summary

Manhole # S37EE1021MH

Location Address: **3734 OLD YORK RD**

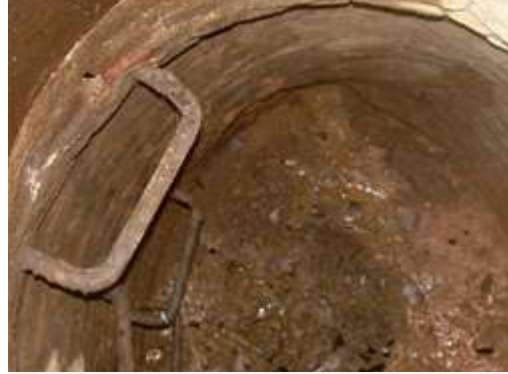
Top View

Channel debris.

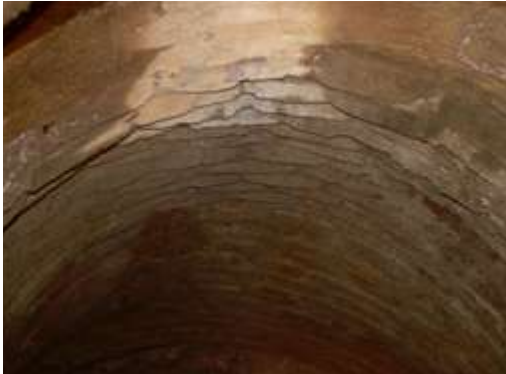
Defect

☒ **Leaks**

Infiltration: ☐ None ☒ **Joint** ☐ Cracks ☐ Mortar ☐ Roots ☒ **Wall**

Frame leaks. Adjustment and Barrel infiltration.

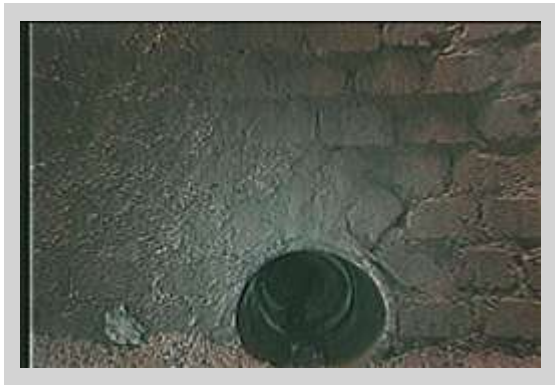
8 in. Circular Gravity Sewer
Pipe Out @ 12 O'Clock

Condition: ☐ Sound ☐ Cracked ☐ Root Intrusion ☐ Loose Brick ☒ **Deteriorated**

Infiltration: ☐ None ☐ Joint ☐ Cracks ☒ **Mortar** ☐ Roots ☒ **Wall**

Barrel deterioration and infiltration.
